# Chapter 14

### Geophysical Investigations of Alleged Quarry Blast Damage to Buildings in Lokgwabe Village

#### **ABSTRACT**

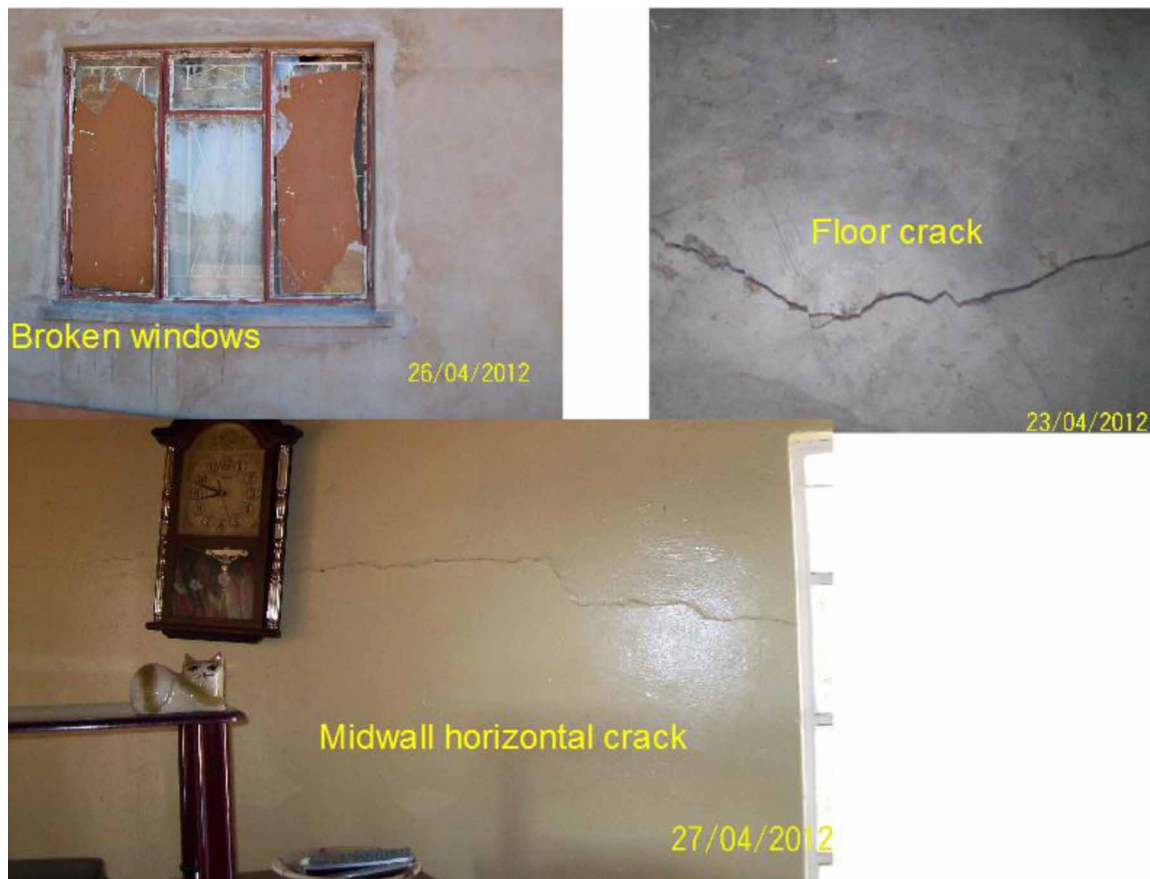
The houses that are allegedly damaged comprise mostly cement brick work and plaster, while others have clay brick improvements on the front. The reported damage includes the development of cracks propagating on the walls from wall plate downwards to the lower level of the windows, cracks on the floor, broken window panes, plaster peeling off the brickwork, and excessive shaking of the ceiling. In one case the ceiling is reported to have fallen off the brandering (Figure 1). A wooden door frame is also reported to have shaken off the wall at one of the houses. Although most house-holds in Lokgwabe

*Figure 1. Photographs showing the damage reported on some of the Lokgwabe buildings*
